**Flood Control Project Maintenance  
Levee Inspections**  
**LMA District Cover Sheet**  
**Spring 2019 Levee Inspection Results**

**Reclamation District No. 0003 Grand Island**

**Spring 2019 Levee Inspection Results**

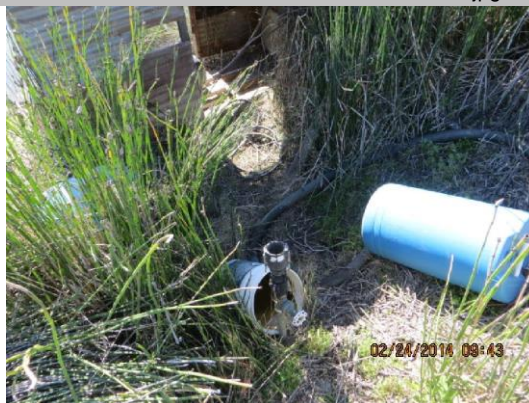
Photo 2 of 3 : UCIP\_SP\_2019\_30864\_56746.jpg

Vent next to pumphouse on WS slope.

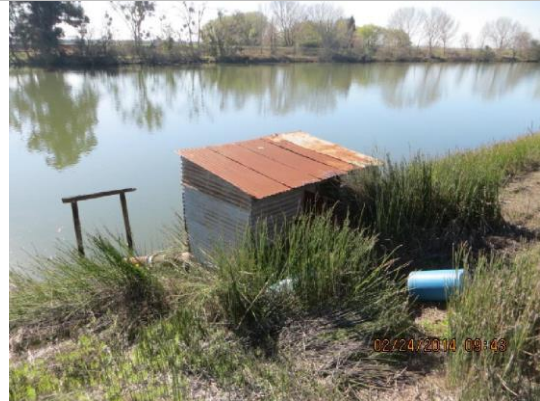
Photo 3 of 3 : UCIP\_SP\_2019\_30864\_56745.jpg

Comment Code						
Inspector Comment						
FS_ID:30864 DS_ID:22238 EP_NO: 9430 Repair Type: Non-Urgent Crossing Status: Found UCIP Comments: Annular space not grouted. FIELD_STRUCT_DESC: 12-inch steel irrigation discharge pipe through the levee, invert elevation 4 feet below the crown. 8-inch pipe sleeved through the 12-inch pipe. Pump and gate valve in a pump house and a vent on the waterside (WS) slope. Siphon breaker in a 16-inch corrugated metal pipe (CMP) riser on the landside (LS) shoulder. 4-foot concrete standpipe, power pole, and meter on the LS toe. (Retention of an irrigation pumping plant with a centrifugal pump and accessories in a corrugated metal shed on the WS slope above rock authorized under Automatic Board Order (ABO) issued as Permit No. 9430, 1974 - M. B. Millhauser). [Additional Reference(s): DWR Levee Log, 1993. USACE Sacramento O&M Manual 104, February 1960, (RM 20.99)]. FS Date: 2/24/2014

Pumphouse on WS slope.

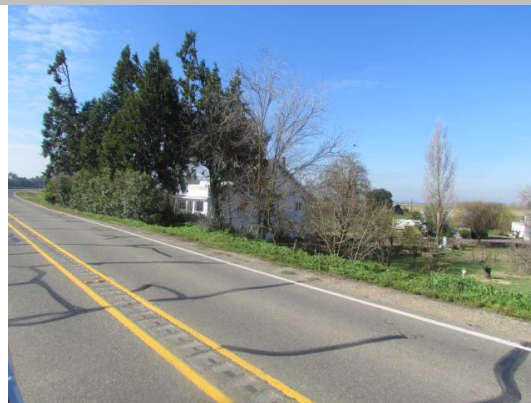
Photo 1 of 1 : SP\_2019\_RD0003\_25\_88\_20190311\_00068.jpg

LM Start	6.54	Rating **	M	Issue No.	88
LM End	6.57	Issue Type +	En	Location *	LS
Category	Earthen Levee			GPS Latitude/Longitude	
				Start	End
Item	Vegetation			38.201390 °	38.201921 °
				-121.558934 °	-121.558866 °
DWR ID	DWR_RD0003_02_s_2012_88				
Comment Code					
V6 : Landscaping					
Inspector Comment

Looking south at landscaping on landside shoulder.

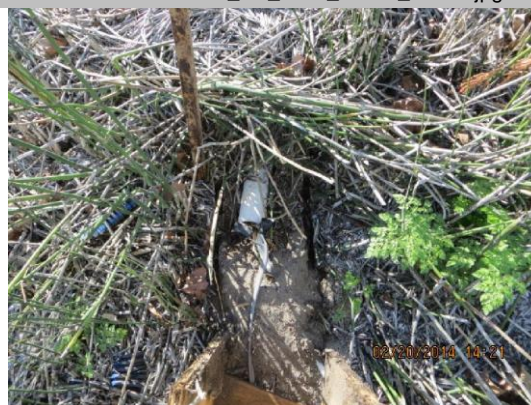
Photo 1 of 2 : UCIP\_SP\_2019\_31291\_57310.jpg

LM Start	6.54	Rating **	M	Issue No.	965	
LM End	6.54	Issue Type +	En	Location *		
Category	Supplemental			GPS Latitude/Longitude		
				Start	End	
Item	DWR UCIP Field Study			38.201393 °	38.201393 °	
				-121.558905 °	-121.558905 °	
DWR ID	24841					
Comment Code						
Inspector Comment						
FS_ID:31291 DS_ID:24841 EP_NO: N/A Repair Type: Non-Urgent Crossing Status: Found UCIP Comments: No permit identified for this crossing. FIELD_STRUCT_DESC: 2.5-inch polyvinyl chloride (PVC) conduit, 4 feet below the crown. 0.5-inch water line and electrical line sleeved through the conduit. Conduit provides service to a boat dock. This crossing was field discovered. FS Date: 2/20/2014

Pipe visible on WS slope.

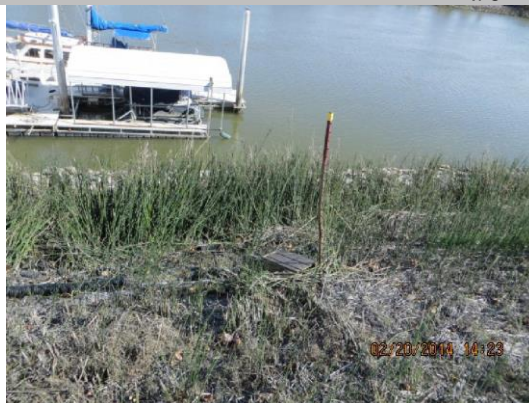
Photo 2 of 2 : UCIP\_SP\_2019\_31291\_57309.jpg

Pipe visible on WS slope.

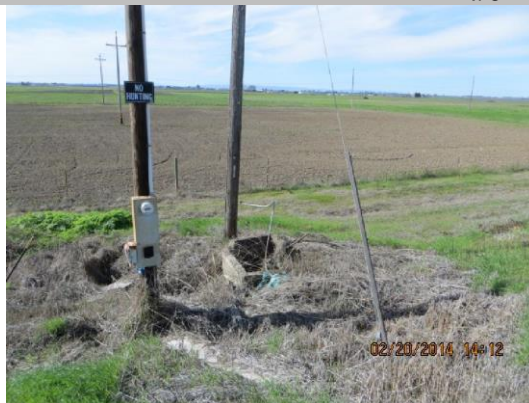
Photo 1 of 3 : UCIP\_SP\_2019\_30672\_56446.jpg

LM Start	6.66	Rating **	M	Issue No.	966
LM End	6.66	Issue Type +	En	Location *	
Category	Supplemental			GPS Latitude/Longitude	
				Start	End
Item	DWR UCIP Field Study			38.203115 °	38.203115 °
				-121.558665 °	-121.558665 °
DWR ID	22242				
Comment Code					
Inspector Comment					
FS_ID:30672 DS_ID:22242 EP_NO: N/A Repair Type: Non-Urgent Crossing Status: Found UCIP Comments: Appears abandoned and if so should be done so properly. FIELD_STRUCT_DESC: *ABANDONED* 7-inch steel irrigation discharge pipe through the levee, invert elevation 7.6 feet below the crown. Pump in a pump house on a concrete pad on the waterside (WS) slope. Gate valve on the WS slope. 44-inch by 44-inch concrete distribution box, joint pole (JP), and meter at the landside (LS) toe. [Additional Reference(s): DWR Levee Log, 1993. USACE Sacramento O&M Manual 104, February 1960, (RM 21.58)]. FS Date: 2/20/2014

Concrete distribution box, power pole, and meter on LS toe.

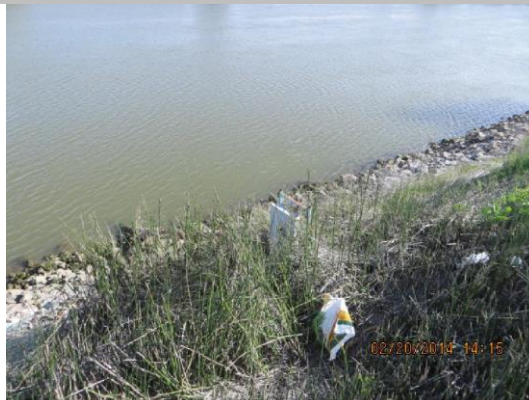
Photo 2 of 3 : UCIP\_SP\_2019\_30672\_56445.jpg

Pump in vegetation on WS slope.

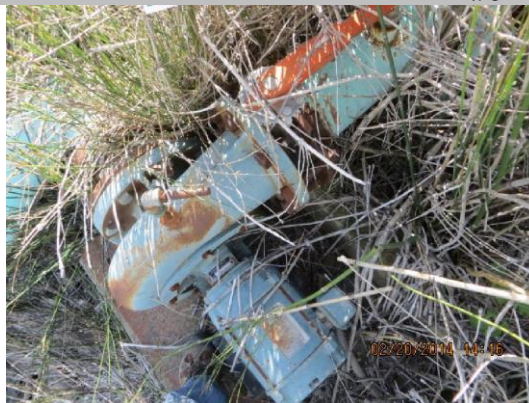
Photo 3 of 3 : UCIP\_SP\_2019\_30672\_56444.jpg

Comment Code						
Inspector Comment						
FS_ID:30672 DS_ID:22242 EP_NO: N/A Repair Type: Non-Urgent Crossing Status: Found UCIP Comments: Appears abandoned and if so should be done so properly. FIELD_STRUCT_DESC: *ABANDONED* 7-inch steel irrigation discharge pipe through the levee, invert elevation 7.6 feet below the crown. Pump in a pump house on a concrete pad on the waterside (WS) slope. Gate valve on the WS slope. 44-inch by 44-inch concrete distribution box, joint pole (JP), and meter at the landside (LS) toe. [Additional Reference(s): DWR Levee Log, 1993. USACE Sacramento O&M Manual 104, February 1960, (RM 21.58)]. FS Date: 2/20/2014

Pump on pad with butterfly valve on WS slope.

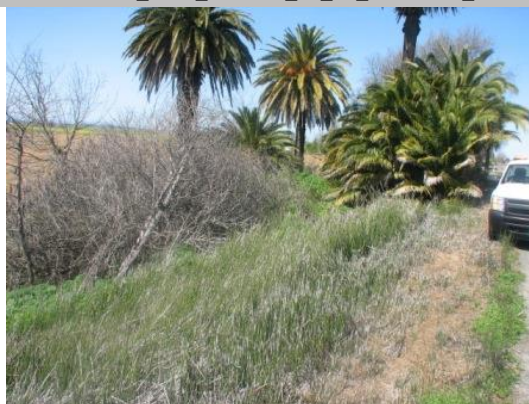
Photo 1 of 3 : SP\_2019\_RD0003\_25\_12\_20190311\_00013.jpg

LM Start	6.88	Rating **	U	Issue No.	12
LM End	6.90	Issue Type +	En	Location *	LS
Category	Earthen Levee			GPS Latitude/Longitude	
				Start	End
Item	Vegetation			38.206363 °	38.206598 °
				-121.558520 °	-121.558530 °
DWR ID	DWR_RD0003_02_s_2012_12				
Comment Code					
V6 : Landscaping					
Inspector Comment					
There are palm trees on the landside slope.

Dense trees at landside toe and shoulder.

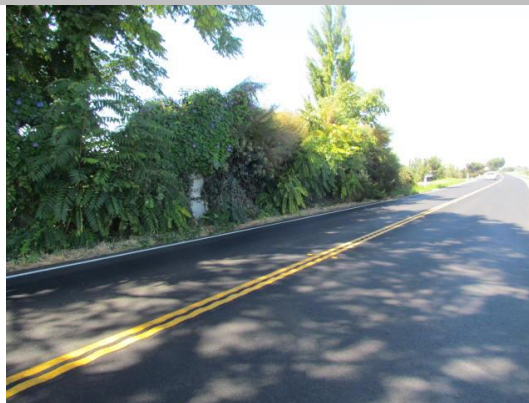
Photo 1 of 1 : SP\_2019\_RD0003\_25\_55\_20190311\_00038.jpg

LM Start	7.22	Rating **	U	Issue No.	55
LM End	7.22	Issue Type +	En	Location *	LS
Category	Earthen Levee			GPS Latitude/Longitude	
				Start	End
Item	Vegetation			38.211357 °	38.211357 °
				-121.558468 °	-121.558468 °
DWR ID	DWR_RD0003_02_s_2012_55				
Comment Code					
V6 : Landscaping					
Inspector Comment

Looking northwest at dense landscaping on landward shoulder and slope.

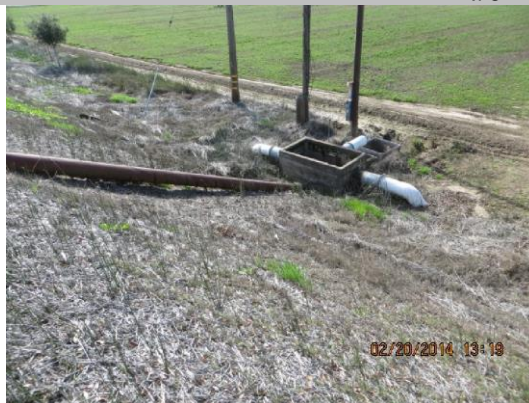
Photo 1 of 3 : UCIP\_SP\_2019\_30648\_56414.jpg

Comment Code						
Inspector Comment						
FS_ID:30648 DS_ID:22247 EP_NO: 1383 Repair Type: Non-Urgent Crossing Status: Found UCIP Comments: 44-inch deep hole on WS slope over pipe 3-inches in diameter. FIELD_STRUCT_DESC: 12-inch steel irrigation discharge pipe through the levee, invert elevation 4 feet below the crown. Concrete pump house on the waterside (WS) slope. 5-foot by 7-foot concrete distribution box at the landside (LS) toe with a pole and meter. (Plans for the installation of an irrigation pumping plant and a 12-inch steel discharge pipe through the levee authorized under Permit No. 1383, 1949 - Kate A. Berlin and Frank L. Fallman). [Additional Reference(s): DWR Levee Log, 1993. USACE Sacramento O&M Manual 104, February 1960, (RM 22.33)]. FS Date: 2/20/2014

Pipe visible on LS slope with concrete distribution box on LS toe.

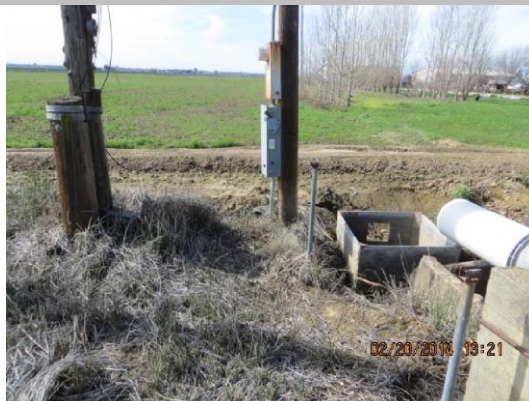
Photo 2 of 3 : UCIP\_SP\_2019\_30648\_56413.jpg

Meter on pole next to concrete distribution box on LS toe.

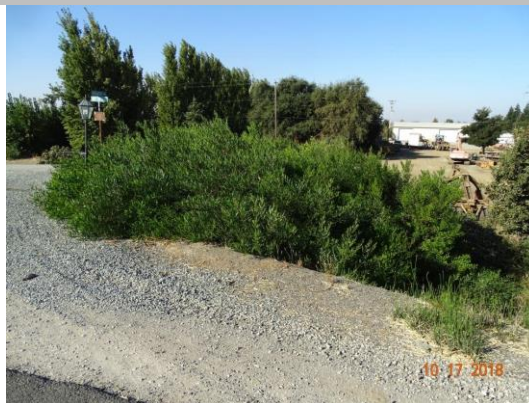
Photo 1 of 1 : SP\_2019\_RD0003\_25\_189\_20190311\_00151.jpg

LM Start	7.43	Rating **	U	Issue No.	189
LM End	7.43	Issue Type +	En	Location *	LS
Category	Earthen Levee			GPS Latitude/Longitude	
				Start	End
Item	Vegetation			38.214308 °	38.214308 °
				-121.558654 °	-121.558654 °
DWR ID	DWR_RD0003_02_s_2018_189				
Comment Code					
V6 : Landscaping					
Inspector Comment

View of landscape vegetation on the landside slope (October 2018).

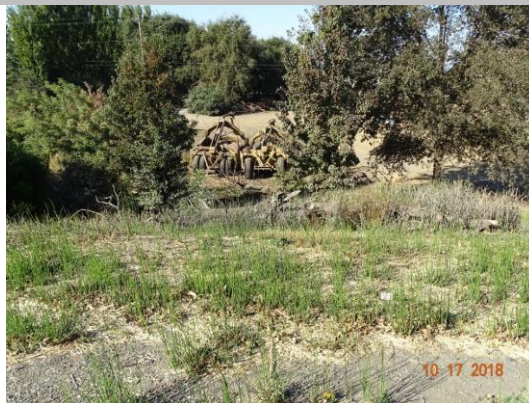
Photo 1 of 1 : SP\_2019\_RD0003\_25\_198\_20190311\_00155.jpg

View of tree at the top of the landside slope (October 2018).

LM Start	7.44	Rating **	U	Issue No.	198
LM End	7.44	Issue Type +	En	Location *	LS
Category	Earthen Levee			GPS Latitude/Longitude	
				Start	End
Item	Encroachments			38.214553 °	38.214553 °
				-121.558618 °	-121.558618 °
DWR ID	DWR_RD0003_02_f_2018_198				
Comment Code					
TR : Tree or limb					
Inspector Comment					
Remove tree from landside slope.

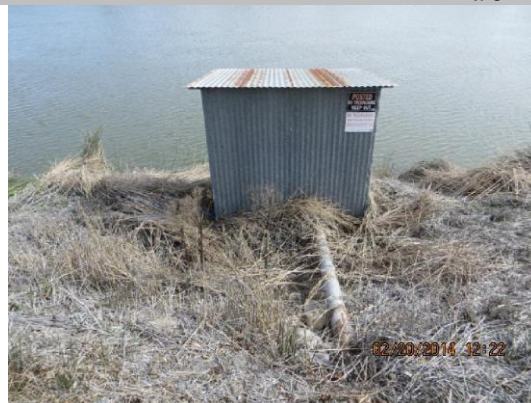
Photo 1 of 3 : UCIP\_SP\_2019\_30643\_56402.jpg

Comment Code						
Inspector Comment						
FS_ID:30643						
DS_ID:22249						
EP_NO: N/A						
Repair Type: Non-Urgent						
Crossing Status: Found						
UCIP Comments: Appears abandoned and if so should be done so properly.						
FIELD_STRUCT_DESC: 6-inch steel irrigation discharge pipe through the levee, invert elevation 3.5 feet below the crown. Pump and gate valve in a pump house on the waterside (WS) slope. 36-inch concrete standpipe on the landside (LS). 1.5-inch electrical conduit through the levee at the same location. Power pole and meter on the LS slope. (L. Souza). [Additional Reference(s): DWR Levee Log, 1993. USACE Sacramento O&M Manual 104, February 1960, (RM 22.60)].						
FS Date: 2/20/2014

Pumphouse on WS slope.

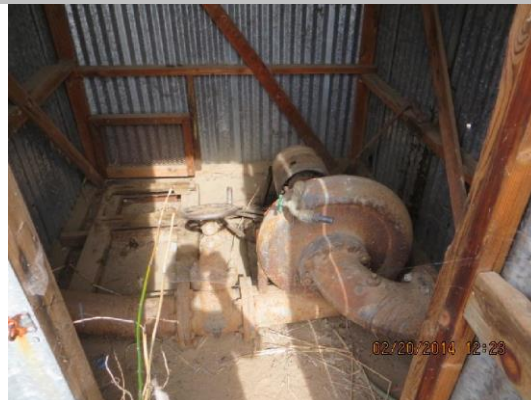
Photo 2 of 3 : UCIP\_SP\_2019\_30643\_56401.jpg

Pump, gate valve and pipe visible in pumphouse on WS slope.

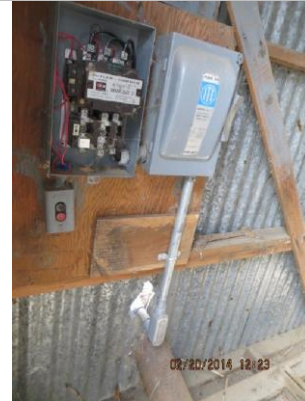
Photo 3 of 3 : UCIP\_SP\_2019\_30643\_56400.jpg

Comment Code						
Inspector Comment						
FS_ID:30643						
DS_ID:22249						
EP_NO: N/A						
Repair Type: Non-Urgent						
Crossing Status: Found						
UCIP Comments: Appears abandoned and if so should be done so properly.						
FIELD_STRUCT_DESC: 6-inch steel irrigation discharge pipe through the levee, invert elevation 3.5 feet below the crown. Pump and gate valve in a pump house on the waterside (WS) slope. 36-inch concrete standpipe on the landside (LS). 1.5-inch electrical conduit through the levee at the same location. Power pole and meter on the LS slope. (L. Souza). [Additional Reference(s): DWR Levee Log, 1993. USACE Sacramento O&M Manual 104, February 1960, (RM 22.60)].						
FS Date: 2/20/2014

Electrical panel inside pumphouse on WS slope.

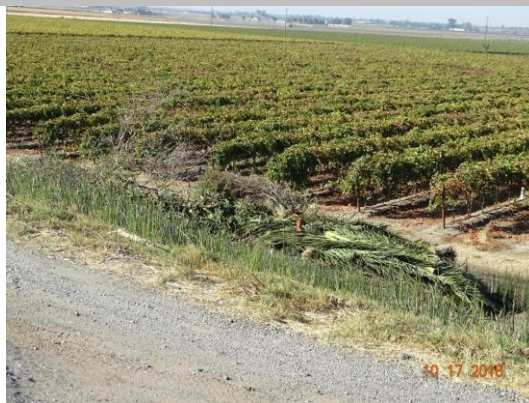
Photo 1 of 1 : SP\_2019\_RD0003\_25\_177\_20190311\_00148.jpg

LM Start	8.01	Rating **	M	Issue No.	177
LM End	8.01	Issue Type +	En	Location *	LS
Category	Earthen Levee			GPS Latitude/Longitude	
				Start	End
Item	Encroachments			38.222673 °	38.222673 °
				-121.557539 °	-121.557539 °
DWR ID	DWR_RD0003_02_f_2017_177				
Comment Code					
PR : Prunings					
Inspector Comment

View of prunings on the landside slope (October 2018).

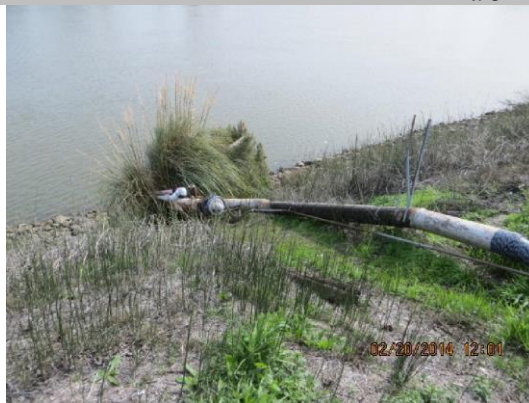
Photo 1 of 2 : UCIP\_SP\_2019\_30623\_56381.jpg

Comment Code					
Inspector Comment					
FS_ID:30623 DS_ID:22251 EP_NO: 886 Repair Type: Non-Urgent Crossing Status: Found UCIP Comments: Erosion under pipe on LS slope. FIELD_STRUCT_DESC: 10-inch steel irrigation discharge pipe through the levee, invert elevation 3.8 feet below the crown. Slant pump on the waterside (WS) slope. 36-inch concrete standpipe at the landside (LS) toe with a filter plant. Service pole on the LS slope. 1.5-inch steel electrical conduit through the levee at the same location. (Plans for the installation and maintenance of an irrigation pumping plant, including an 8-inch discharge pipe through the levee authorized under Permit No. 886, 1942 - Georgia McKuen. Retention of an irrigation pumping plant with a slant pump and a 10-inch steel pipe through the levee above the floodplain and a service pole near the LS shoulder authorized under Automatic Board Order (ABO) issued as Permit No. 9437, 1974 - Joseph Green Jr). [Additional Reference(s): DWR Levee Log, 1993, 12-inch pipe referenced. USACE Sacramento O&M Manual, February 1960, (RM 22.96)]. FS Date: 2/20/2014

Pipe and slant pump on WS slope.

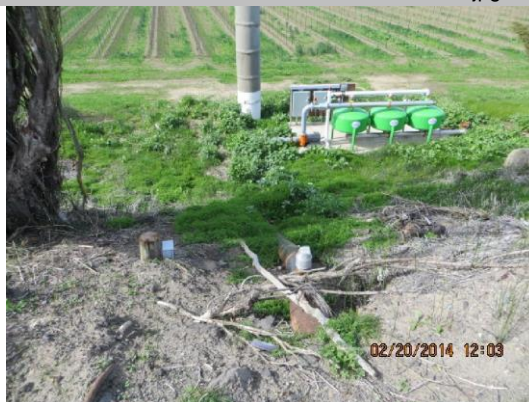
Photo 2 of 2 : UCIP\_SP\_2019\_30623\_56380.jpg

vent, pipe, standpipe, and filter plant on LS.

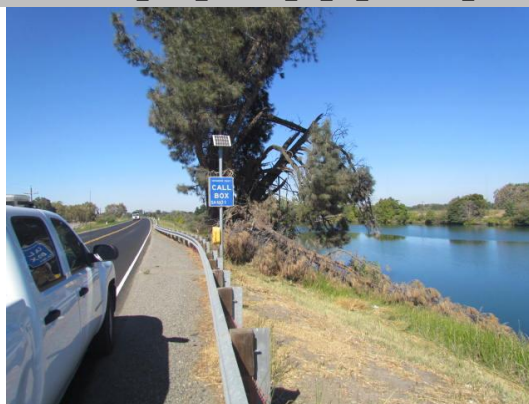
Photo 1 of 2 : SP\_2019\_RD0003\_25\_15\_20190311\_00018.jpg

LM Start	8.11	Rating **	U	Issue No.	15
LM End	8.11	Issue Type +	Ma	Location *	WS
Category	Earthen Levee			GPS Latitude/Longitude	
				Start	End
Item	Encroachments			38.224130 °	38.224130 °
				-121.557206 °	-121.557206 °
DWR ID	DWR_RD0003_02_f_2015_15				
Comment Code					
TR : Tree or limb					
Inspector Comment					
Remove broken tree branches on waterside shoulder and slope.

Looking northeast at broken and cracked tree branches on waterward slope.

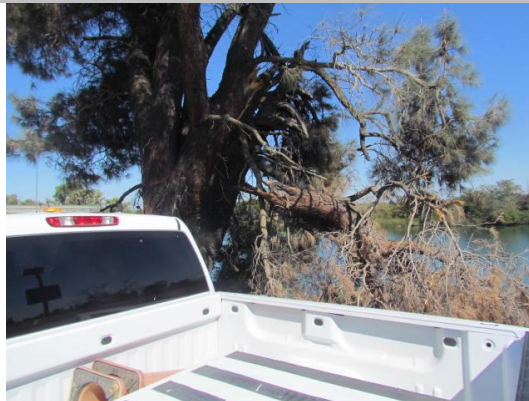
Photo 2 of 2 : SP\_2019\_RD0003\_25\_15\_20190311\_00019.jpg

LM Start	8.11	Rating **	U	Issue No.	15 (cont)	
LM End	8.11	Issue Type +	Ma	Location *	WS	
Category	Earthen Levee			GPS Latitude/Longitude		
				Start		End
Item	Encroachments			38.224130 °		38.224130 °
				-121.557206 °		-121.557206 °
DWR ID	DWR_RD0003_02_f_2015_15					
Comment Code						
TR : Tree or limb						
Inspector Comment						
Remove broken tree branches on waterside shoulder and slope.

Looking east at broken and cracked tree branches on waterward slope.

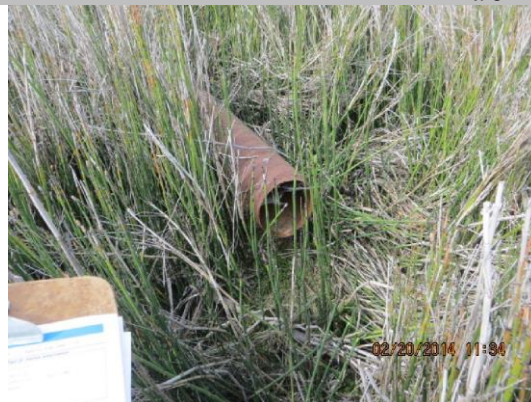
Photo 2 of 3 : UCIP\_SP\_2019\_53485\_56370.jpg

Open pipe visible on WS slope.

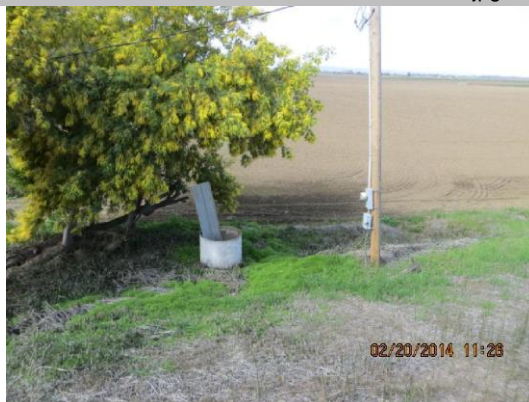
Photo 2 of 3 : UCIP\_SP\_2019\_30577\_56344.jpg

Comment Code					
Inspector Comment					
FS_ID:30577					
DS_ID:22257					
EP_NO: 3593					
Repair Type: Non-Urgent					
Crossing Status: Found					
UCIP Comments: Siphon breaker broken off pipe on LS slope.					
FIELD_STRUCT_DESC: 12-inch coated steel irrigation discharge pipe through the levee, 4 feet below the crown. Pump on a concrete pad on the waterside (WS) slope. 42-inch concrete standpipe at the landside (LS) toe. Siphon breaker on the LS slope. Project drawings included with permit. 1-inch electrical conduit through the levee at the same location. (Plans for construction of a pumping plant on the WS authorized under Permit No. 3593, 1961 - Nelson Dean). [Additional Reference(s): DWR Levee Log, 1993].					
FS Date: 2/20/2014

Concrete standpipe, powerpole, and meter visible on LS toe.

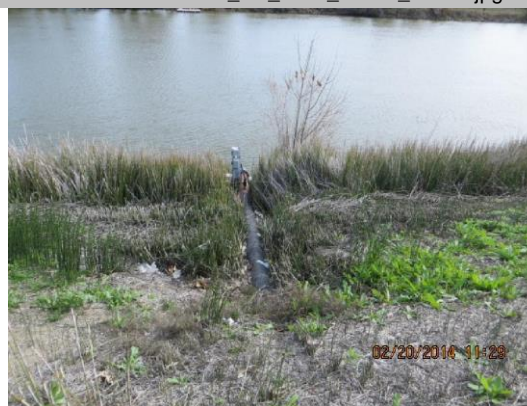
Photo 3 of 3 : UCIP\_SP\_2019\_30577\_56346.jpg

Comment Code						
Inspector Comment						
FS_ID:30577 DS_ID:22257 EP_NO: 3593 Repair Type: Non-Urgent Crossing Status: Found UCIP Comments: Siphon breaker broken off pipe on LS slope. FIELD_STRUCT_DESC: 12-inch coated steel irrigation discharge pipe through the levee, 4 feet below the crown. Pump on a concrete pad on the waterside (WS) slope. 42-inch concrete standpipe at the landside (LS) toe. Siphon breaker on the LS slope. Project drawings included with permit. 1-inch electrical conduit through the levee at the same location. (Plans for construction of a pumping plant on the WS authorized under Permit No. 3593, 1961 - Nelson Dean). [Additional Reference(s): DWR Levee Log, 1993]. FS Date: 2/20/2014

Pump and pipe visible on WS slope.

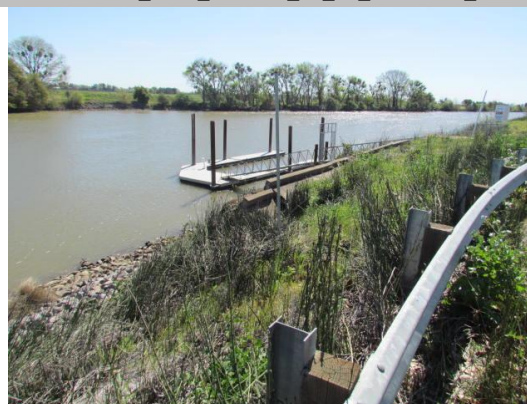
Photo 1 of 1 : SP\_2019\_RD0003\_25\_59\_20190311\_00040.jpg

LM Start	8.43	Rating **	M	Issue No.	59
LM End	8.43	Issue Type +	En	Location *	WS
Category	Earthen Levee			GPS Latitude/Longitude	
				Start	End
Item	Encroachments			38.229251 °	38.229251 °
				-121.557227 °	-121.557227 °
DWR ID	DWR_RD0003_02_s_2012_59				
Comment Code					
MA : Material					
Inspector Comment					
There are concrete footings and retaining walls at the levee toe and slopes. They have been in place for several years.

Looking southeast at concrete structure on waterward slope.

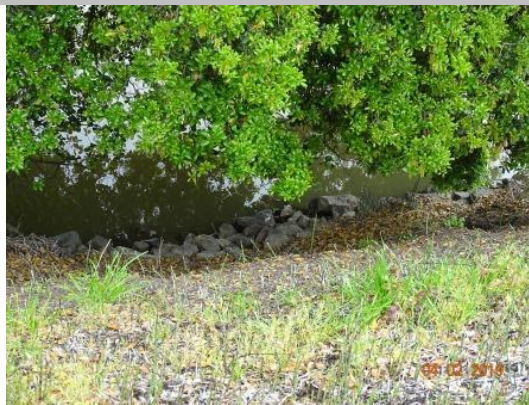
Photo 1 of 1 : SP\_2019\_RD0003\_25\_196\_20190404\_00318.jpg

LM Start	8.67	Rating **	M	Issue No.	196
LM End	8.67	Issue Type +	Ma	Location *	WS
Category	Earthen Levee			GPS Latitude/Longitude	
				Start	End
Item	Erosion / Bank Caving			38.232066 °	-121.558586 °
				38.232066 °	-121.558586 °
DWR ID	DWR_RD0003_02_s_2019_196				
Comment Code					
E1 : Note and monitor erosion site.					
Inspector Comment					
There is a bench on the waterside slope.

View looking downslope at erosion on the waterside slope (Spring 2019).

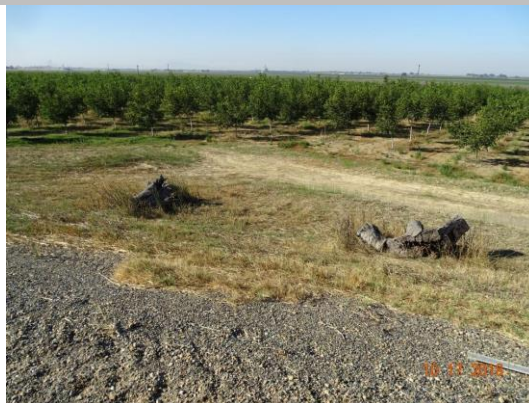
Photo 1 of 1 : SP\_2019\_RD0003\_25\_195\_20190311\_00153.jpg

LM Start	8.75	Rating **	M	Issue No.	195
LM End	8.75	Issue Type +	En	Location *	LS
Category	Earthen Levee			GPS Latitude/Longitude	
				Start	End
Item	Encroachments			38.233052 °	38.233052 °
				-121.559152 °	-121.559152 °
DWR ID	DWR_RD0003_02_f_2018_195				
Comment Code					
TR : Tree or limb					
Inspector Comment					
Remove logs from the landside slope.

View of logs on the landside slope (October 2018).

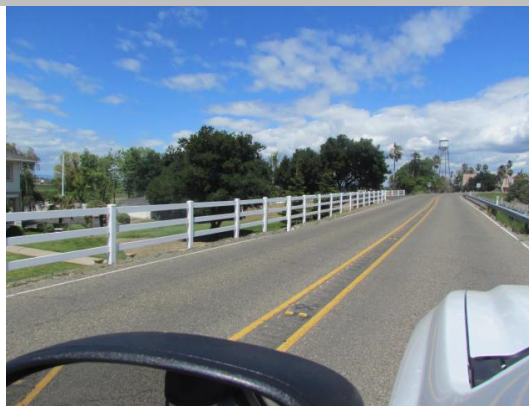
Photo 1 of 1 : SP\_2019\_RD0003\_25\_78\_20190311\_00056.jpg

LM Start	8.85	Rating **	M	Issue No.	78
LM End	8.93	Issue Type +	En	Location *	LS
Category	Earthen Levee			GPS Latitude/Longitude	
				Start	End
Item	Encroachments			38.234516 °	38.235630 °
				-121.559502 °	-121.559640 °
DWR ID	DWR_RD0003_02_s_2013_78				
Comment Code					
FE : Fence					
Inspector Comment					
There is an unauthorized fence along this stretch.

Looking northwest at unauthorized fence on landward shoulder.

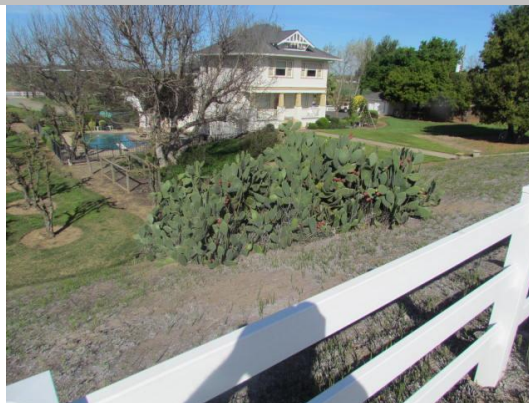
Photo 1 of 1 : SP\_2019\_RD0003\_25\_158\_20190311\_00137.jpg

LM Start	8.87	Rating **	U	Issue No.	158
LM End	8.87	Issue Type +	En	Location *	LS
Category	Earthen Levee			GPS Latitude/Longitude	
				Start	End
Item	Vegetation			38.234759 °	38.234759 °
				-121.559534 °	-121.559534 °
DWR ID	DWR_RD0003_02_s_2015_158				
Comment Code					
V6 : Landscaping					
Inspector Comment					
There is a large cluster of cactus on the landside slope.

Looking west at cactus on landward slope and toe.

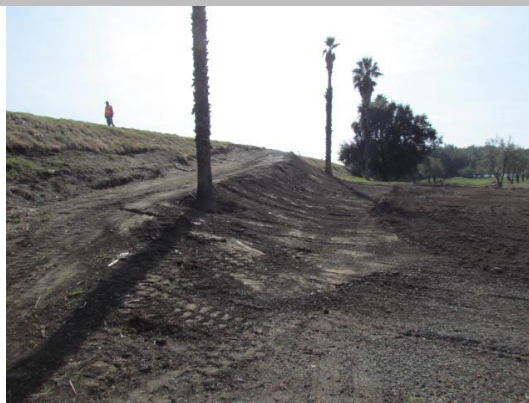
Photo 1 of 3 : SP\_2019\_RD0003\_25\_2\_20190311\_00001.jpg

LM Start	9.01	Rating **	M	Issue No.	2
LM End	9.01	Issue Type +	En	Location *	LS
Category	Earthen Levee			GPS Latitude/Longitude	
				Start	End
Item	Encroachments			38.236877 °	38.236877 °
				-121.559528 °	-121.559528 °
DWR ID	DWR_RD0003_02_s_2012_2				
Comment Code					
RA : Ramp					
Inspector Comment					
New landowner installed an unauthorized ramp on the landside slope. The district engineer has spoken with the landowner about removing the ramp. Wild grape vines are growing on the ramp slope.

Looking south at unauthorized ramp on landside slope.

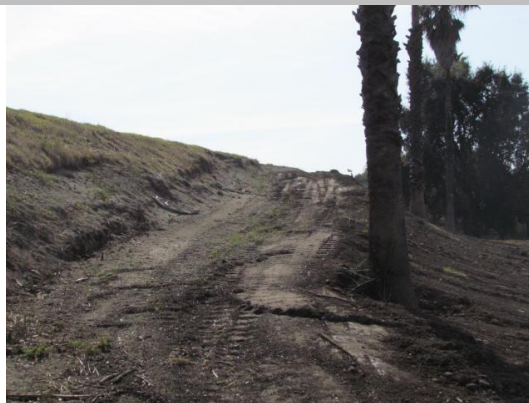
Photo 3 of 3 : SP\_2019\_RD0003\_25\_2\_20190311\_00003.jpg

LM Start	9.01	Rating **	M	Issue No.	2 (cont)	
LM End	9.01	Issue Type +	En	Location *	LS	
Category	Earthen Levee			GPS Latitude/Longitude		
				Start		End
Item	Encroachments			38.236877 °		38.236877 °
				-121.559528 °		-121.559528 °
DWR ID	DWR_RD0003_02_s _ 2012_2					
Comment Code						
RA : Ramp						
Inspector Comment						
New landowner installed an unauthorized ramp on the landside slope. The district engineer has spoken with the landowner about removing the ramp. Wild grape vines are growing on the ramp slope.

Looking south at ramp on landside slope.

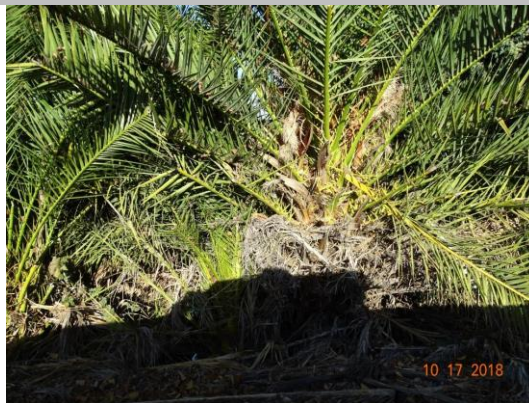
Photo 1 of 1 : SP\_2019\_RD0003\_25\_182\_20190311\_00150.jpg

LM Start	9.16	Rating **	U	Issue No.	182	
LM End	9.16	Issue Type +	En	Location *	LS	
Category	Earthen Levee			GPS Latitude/Longitude		
				Start		End
Item	Vegetation			38.238812 °		38.238812 °
				-121.558187 °		-121.558187 °
DWR ID	DWR_RD0003_02_f_2018_182					
Comment Code						
V6 : Landscaping						
Inspector Comment						
Palm trees are blocking the view of the levee.

View of palm trees at the top of the landside slope (October 2018).

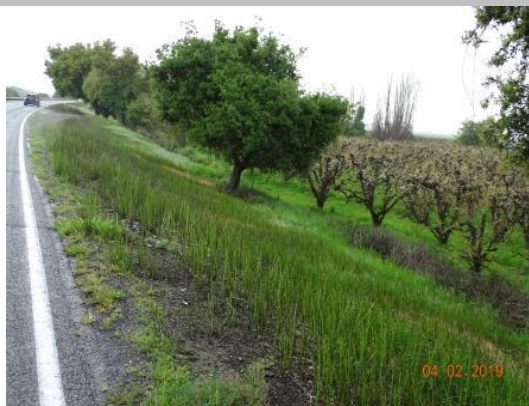
Photo 1 of 1 : SP\_2019\_RD0003\_25\_184\_20190404\_00334.jpg

LM Start	9.19	Rating **	U	Issue No.	184
LM End	10.73	Issue Type +	Ma	Location *	LS
Category	Earthen Levee			GPS Latitude/Longitude	
				Start	End
Item	Vegetation			38.239175 °	38.238799 °
				-121.557848 °	-121.531847 °
DWR ID	DWR_RD0003_02_s_2019_184				
Comment Code					
V1 : Control annual grass and weeds on the levee slopes and easements.					
Inspector Comment					
Control annual vegetation.

View looking downstream at annual vegetation on the landside slope (Spring 2019).

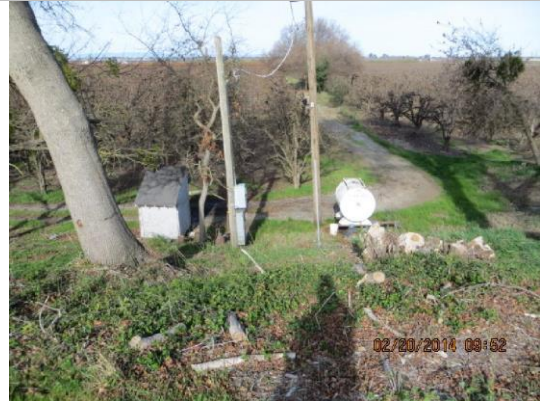
Photo 3 of 3 : UCIP\_SP\_2019\_30507\_56118.jpg

Comment Code						
Inspector Comment						
FS_ID:30507 DS_ID:22271 EP_NO: 3295 Repair Type: Non-Urgent Crossing Status: Found UCIP Comments: Possibly Abandoned and if so should be done properly. Pipe shows sigs of decay on LS toe and there is pipe debris on the WS slope. Good candidate for video inspection. FIELD_STRUCT_DESC: 10-inch steel irrigation discharge pipe through the levee, 6.5 feet below the crown. Pump on the waterside (WS) slope with a gate valve. Gate valve, power pole, and meter visible on the landside (LS) toe. 1.5-inch steel electrical conduit through the levee at the same location. (Plans for installation of a pump and motor on the WS slope of the levee and installation of an 8-inch pipe through an existing 12-inch pipe through the levee authorized under Permit No. 3295, 1960 - Robert and Craig James). [Additional Reference(s): DWR Levee Log, 1993]. FS Date: 2/20/2014

Pipe to left of power pole and meter at LS toe.

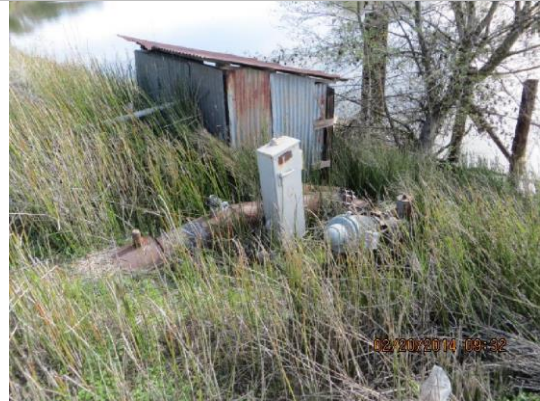
Photo 1 of 3 : UCIP\_SP\_2019\_53270\_57439.jpg

FS\_ID:53270  
DS\_ID:22272  
EP\_NO: 1136  
Repair Type: Urgent  
Crossing Status: Found  
UCIP Comments: 07/20/2018 Everything appears to be the same as last time. No changes have been made. This crossing remains "Urgent": need to determine the condition of the pipe through the levee. (A. McDonald - DWR UCIP)07/06/2016 Highway has been since paved so pot hole not visible. No evidence of repair. (DWR UCIP - kfazel)02/20/2014 Dip in pavement over pipe on North bound lane may indicate internal leak in pipe. Good candidate for video inspection. (DWR UCIP - pamatya)  
FIELD\_STRUCT\_DESC: 16-inch steel irrigation discharge pipe through the levee, invert elevation 6.2 feet below the crown. 12-inch steel pipe sleeved through the existing 16-inch pipe with the annular space grouted. Slant pump on the waterside (WS) slope next to the pump house. Butterfly valve and siphon breaker/vent at the pump on the WS slope. Siphon breaker/vent on the landside (LS) shoulder. Filter, pump, vent, and butterfly valve at the LS toe. The current 16-inch pipe replaced the abandoned 10-inch pipe under DSID 22273. (Plans for plugging up an existing 10-inch steel discharge pipe and installing a new 16-inch steel discharge pipe through the levee authorized under Permit No. 1136, 1946 - Dennis W. Leary. Plans to install a 12-inch irrigation intake pipe inside an existing 16-inch pipe in the levee authorized under Permit No. 14811, 1988 - Leary Ranch, Inc).

Pump, pipe, butterfly valve, and shed visible on WS slope.

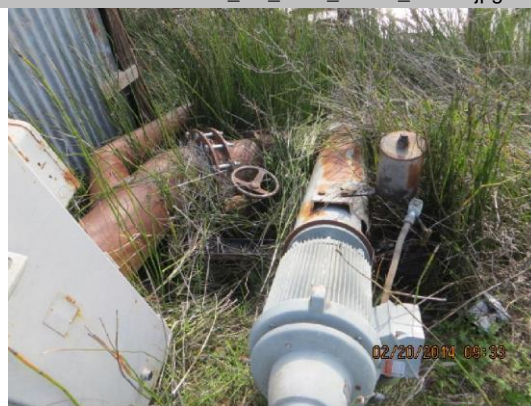
Photo 2 of 3 : UCIP\_SP\_2019\_53270\_57438.jpg

UCIP Comments: 07/20/2018 Everything appears to be the same as last time. No changes have been made. This crossing remains "Urgent": need to determine the condition of the pipe through the levee.

(A. McDonald - DWR UCIP)07/06/2016 Highway has been since paved so pot hole not visible. No evidence of repair. (DWR UCIP - kfazel)02/20/2014 Dip in pavement over pipe on North bound lane may indicate internal leak in pipe. Good candidate for video inspection. (DWR UCIP - pamatya)

Pump, pipe, butterfly valve, and shed visible on WS slope.

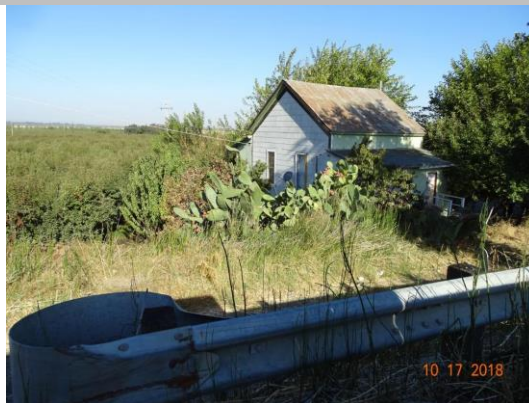
Photo 1 of 1 : SP\_2019\_RD0003\_25\_100\_20190311\_00077.jpg

LM Start	9.35	Rating **	M	Issue No.	100
LM End	9.37	Issue Type +	En	Location *	LS
Category	Earthen Levee			GPS Latitude/Longitude	
				Start	End
Item	Vegetation			38.240997 °	38.241199 °
				-121.556136 °	-121.555867 °
DWR ID	DWR_RD0003_02_f_2013_100				
Comment Code					
V6 : Landscaping					
Inspector Comment					
There is cactus located on the landside slope. Palm trees have been removed.

View of cactus on the landside slope (October 2018).

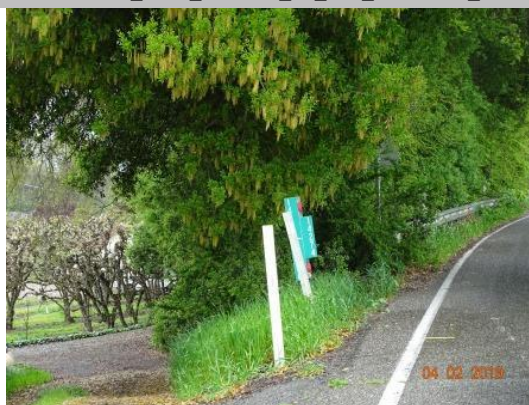
Photo 1 of 1 : SP\_2019\_RD0003\_25\_175\_20190404\_00336.jpg

LM Start	9.43	Rating **	U	Issue No.	175
LM End	9.45	Issue Type +	En	Location *	LS
Category	Earthen Levee			GPS Latitude/Longitude	
				Start	End
Item	Vegetation			38.241752 °	38.241902 °
				-121.555088 °	-121.554792 °
DWR ID	DWR_RD0003_02_f_2018_175				
Comment Code					
V6 : Landscaping					
Inspector Comment					
Trim landscaping trees to allow view down the landside slope.

View looking upstream at landscape vegetation on the landside slope (Spring 2019).

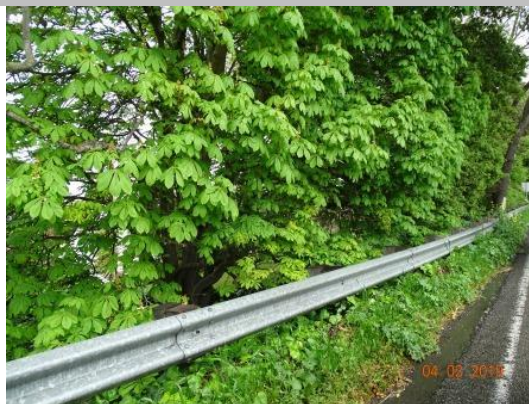
Photo 1 of 1 : SP\_2019\_RD0003\_25\_186\_20190404\_00335.jpg

LM Start	9.47	Rating **	U	Issue No.	186
LM End	9.47	Issue Type +	En	Location *	LS
Category	Earthen Levee			GPS Latitude/Longitude	
				Start	End
Item	Vegetation			38.242031 °	38.242031 °
				-121.554326 °	-121.554326 °
DWR ID	DWR_RD0003_02_s_2019_186				
Comment Code					
V6 : Landscaping					
Inspector Comment					
Trim landscape vegetation on the landside slope.

View looking upstream at landscaping on the landside slope (Spring 2019).

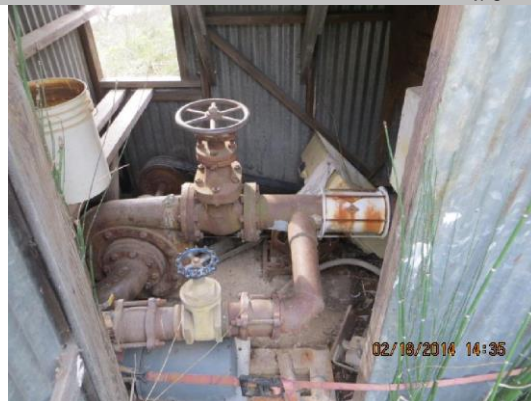
Photo 1 of 3 : UCIP\_SP\_2019\_31349\_57435.jpg

Comment Code					
Inspector Comment					
FS_ID:31349 DS_ID:22275 EP_NO: 3738 Repair Type: Non-Urgent Crossing Status: Found UCIP Comments: Heavy foliage over pipe and appurtances on LS slope. FIELD_STRUCT_DESC: 6-inch steel irrigation discharge pipe through the levee, invert elevation 5.5 feet below the crown. Pump and gate valve in a pump house on the waterside (WS) slope. 1.5-inch steel electrical conduit through the levee at the same location. (Plans to insert a new 4-inch pipe through an existing 6-inch irrigation pipe through the levee authorized under Permit No. 3738, 1961 - Emmett James). [Additional Reference(s): DWR Levee Log, 1993. USACE Sacramento O&M Manual 104, February 1960, (RM 24.48)]. FS Date: 2/18/2014

Pump, pipe, and gate valves in pumphouse on WS slope.

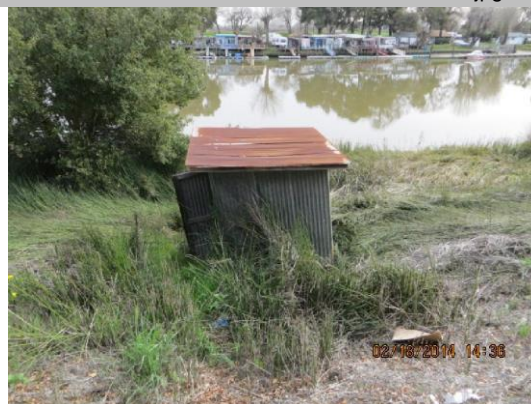
Photo 2 of 3 : UCIP\_SP\_2019\_31349\_57434.jpg

Pumphouse on WS slope.

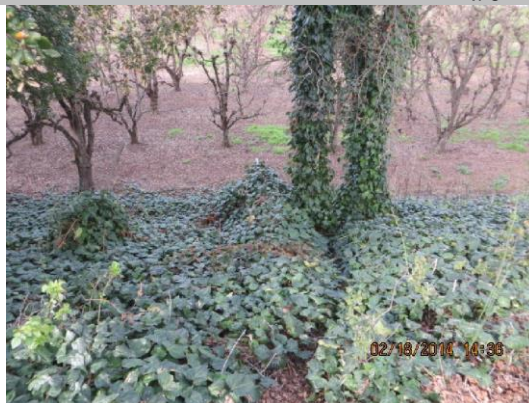
Photo 3 of 3 : UCIP\_SP\_2019\_31349\_57433.jpg

Comment Code						
Inspector Comment						
FS_ID:31349 DS_ID:22275 EP_NO: 3738 Repair Type: Non-Urgent Crossing Status: Found UCIP Comments: Heavy foliage over pipe and appurtances on LS slope. FIELD_STRUCT_DESC: 6-inch steel irrigation discharge pipe through the levee, invert elevation 5.5 feet below the crown. Pump and gate valve in a pump house on the waterside (WS) slope. 1.5-inch steel electrical conduit through the levee at the same location. (Plans to insert a new 4-inch pipe through an existing 6-inch irrigation pipe through the levee authorized under Permit No. 3738, 1961 - Emmett James). [Additional Reference(s): DWR Levee Log, 1993. USACE Sacramento O&M Manual 104, February 1960, (RM 24.48)]. FS Date: 2/18/2014

Pipe visible at LS toe.

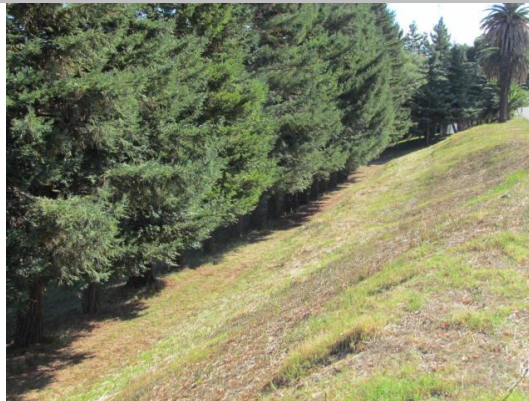
Photo 1 of 2 : SP\_2019\_RD0003\_25\_101\_20190311\_00078.jpg

LM Start	9.63	Rating **	M	Issue No.	101
LM End	9.77	Issue Type +	En	Location *	LS
Category	Earthen Levee			GPS Latitude/Longitude	
				Start	End
Item	Vegetation			38.242471 °	38.242251 °
				-121.551426 °	-121.548970 °
DWR ID	DWR_RD0003_02_f_2013_101				
Comment Code					
V6 : Landscaping					
Inspector Comment					
Large redwood trees are at the landside toe and berm.

Looking northeast at dense redwood trees on landward toe and berm.

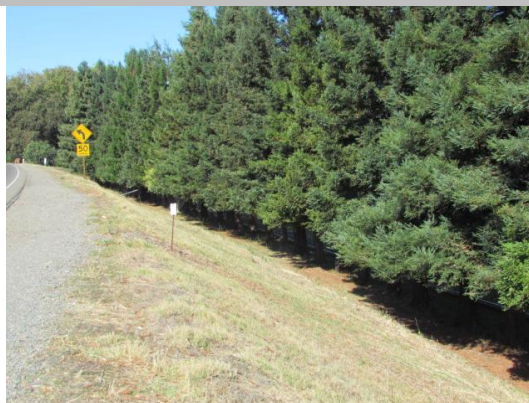
Photo 2 of 2 : SP\_2019\_RD0003\_25\_101\_20190311\_00079.jpg

Looking southwest at dense redwood trees on landward toe and berm.

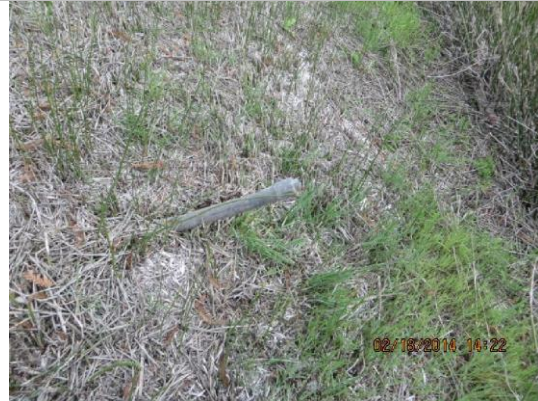
Photo 1 of 1 : UCIP\_SP\_2019\_30424\_55960.jpg

LM Start	9.69	Rating **	M	Issue No.	978	
LM End	9.69	Issue Type +	En	Location *		
Category	Supplemental			GPS Latitude/Longitude		
				Start		End
Item	DWR UCIP Field Study			38.242415 °		38.242415 °
				-121.550452 °		-121.550452 °
DWR ID	22277					
Comment Code						
Inspector Comment						
FS_ID:30424						
DS_ID:22277						
EP_NO: N/A						
Repair Type: Non-Urgent						
Crossing Status: Found						
UCIP Comments: Pipe is not grouted properly.						
FIELD_STRUCT_DESC: *ABANDONED* 14-inch steel irrigation						
discharge pipe through the levee, 5.7 feet below the crown. (Pipe						
capped on both ends by USACE in 1964). 1.5-inch steel electrical						
conduit through the levee at the same location, visible on both sides of						
the levee and capped. [Additional Reference(s): DWR Levee Log, 1993].						
FS Date: 2/18/2014

Electrical conduit visible on WS slope.

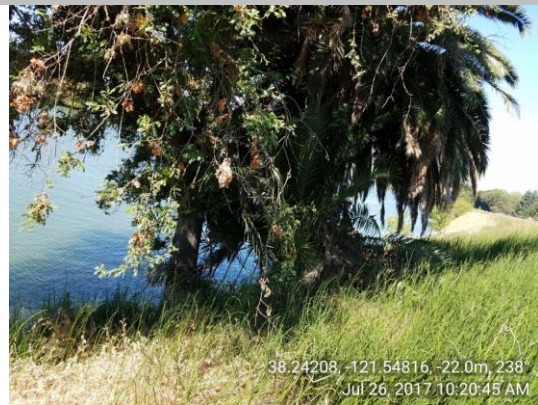
Photo 1 of 3 : SP\_2019\_RD0003\_25\_137\_20190311\_00101.jpg

LM Start	9.82	Rating **	A/W	Issue No.	137
LM End	9.84	Issue Type +	Ma	Location *	
Category	Supplemental			GPS Latitude/Longitude	
				Start	End
Item	2017 Storm Damage			38.242006 °	38.241950 °
				-121.548117 °	-121.547681 °
DWR ID	DWR_RD0003_02_s_2019_137				
Comment Code					
Inspector Comment					
Levee Evaluation Comments					
Description:District station 518+55 to 519+81 , Sec. 33, T. 5 N. R. 4 E., M.D.M. Approximately 126 linear feet of erosion and sloughing exists along the water side slope of the Sacramento River (Unit 2). The erosion commences approximately 1/4 of the way down the slope from the crown and extends into the rip rap.					
Site ID No:279					
Site Designation:LMA-105					
Repair Type: Erosion					
Rating:Area of Concern					
Field Date:7/26/2017					
Notes:

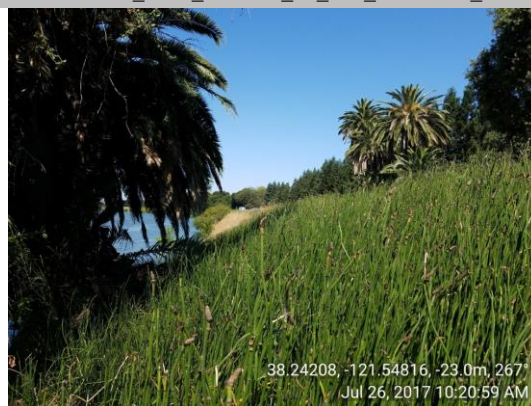
Photo 2 of 3 : SP\_2019\_RD0003\_25\_137\_20190311\_00102.jpg

LM Start	9.82	Rating **	A/W	Issue No.	137 (cont)	
LM End	9.84	Issue Type +	Ma	Location *		
Category	Supplemental			GPS Latitude/Longitude		
				Start	End	
Item	2017 Storm Damage			38.242006°	38.241950°	
				-121.548117°	-121.547681°	
DWR ID	DWR_RD0003_02_s_2019_137					
Comment Code						
Inspector Comment						
Levee Evaluation Comments						
Description: District station 518+55 to 519+81 , Sec. 33, T. 5 N. R. 4 E., M.D.M. Approximately 126 linear feet of erosion and sloughing exists along the water side slope of the Sacramento River (Unit 2). The erosion commences approximately 1/4 of the way down the slope from the crown and extends into the rip rap.						
Site ID No: 279						
Site Designation: LMA-105						
Repair Type: Erosion						
Rating: Area of Concern						
Field Date: 7/26/2017						
Notes:

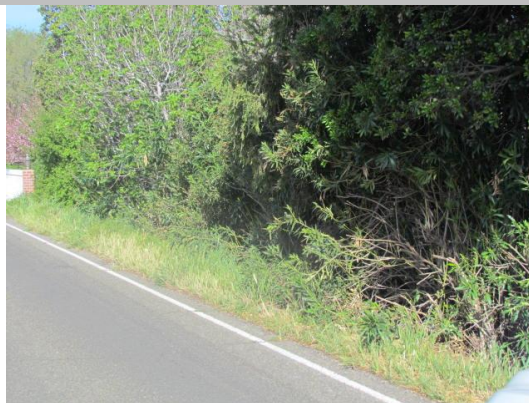
Photo 1 of 1 : SP\_2019\_RD0003\_25\_156\_20190311\_00136.jpg

LM Start	9.85	Rating **	U	Issue No.	156
LM End	9.97	Issue Type +	En	Location *	LS
Category	Earthen Levee			GPS Latitude/Longitude	
				Start	End
Item	Vegetation			38.242068 °	38.241798 °
				-121.547423 °	-121.545394 °
DWR ID	DWR_RD0003_02_s_2015_156				
Comment Code					
V6 : Landscaping					
Inspector Comment					
Dense vegetation is blocking the view down the landside slope.

Looking west at dense landscaping on landward shoulder and slope.

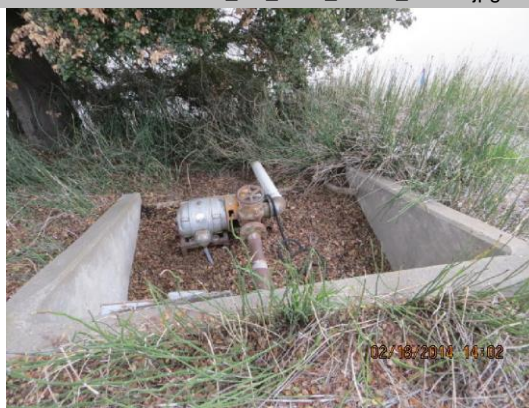
Photo 1 of 3 : UCIP\_SP\_2019\_30408\_55931.jpg

Comment Code					
Inspector Comment					
FS_ID:30408 DS_ID:22280 EP_NO: N/A Repair Type: Non-Urgent Crossing Status: Found UCIP Comments: Annular space not grouted. FIELD_STRUCT_DESC: 6-inch steel irrigation discharge pipe through the levee, invert elevation 5.5 feet below the crown. A 3.5-inch steel pipe is sleeved through a 5-inch pipe which is sleeved through the 6-inch pipe. The annular space is not grouted. Pump and gate valve on the waterside (WS) slope. Concrete distribution box at the landside (LS) toe. 1.5-inch electrical conduit through the levee at the same location. Service pole at the LS toe. (Joe Dianda). [Additional Reference(s): DWR Levee Log, 1993. USACE Sacramento O&M Manual 104, February 1960, (RM 24.88)]. FS Date: 2/18/2014

Pump and shutoff valve on concrete pad on WS slope.

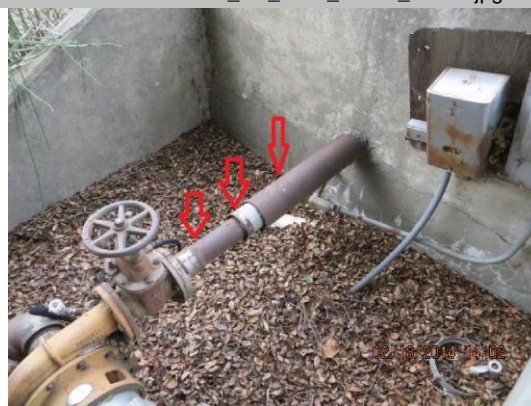
Photo 2 of 3 : UCIP\_SP\_2019\_30408\_55930.jpg

Comment Code						
Inspector Comment						
FS_ID:30408						
DS_ID:22280						
EP_NO: N/A						
Repair Type: Non-Urgent						
Crossing Status: Found						
UCIP Comments: Annular space not grouted.						
FIELD_STRUCT_DESC: 6-inch steel irrigation discharge pipe through the levee, invert elevation 5.5 feet below the crown. A 3.5-inch steel pipe is sleeved through a 5-inch pipe which is sleeved through the 6-inch pipe. The annular space is not grouted. Pump and gate valve on the waterside (WS) slope. Concrete distribution box at the landside (LS) toe. 1.5-inch electrical conduit through the levee at the same location. Service pole at the LS toe. (Joe Dianda). [Additional Reference(s): DWR Levee Log, 1993. USACE Sacramento O&M Manual 104, February 1960, (RM 24.88)].						
FS Date: 2/18/2014

2 pipes sleeved through 6-inch pipe.

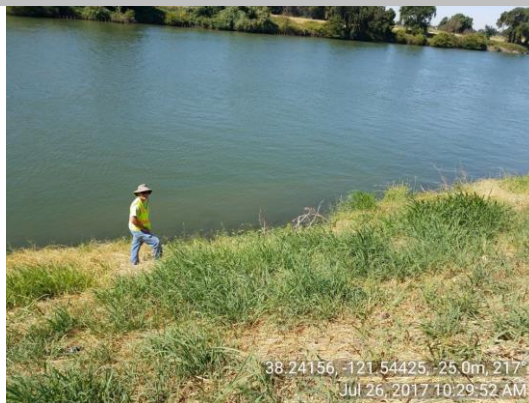
Photo 1 of 3 : SP\_2019\_RD0003\_25\_138\_20190311\_00104.jpg

LM Start	10.01	Rating **	A/W	Issue No.	138
LM End	10.03	Issue Type +	Ma	Location *	
Category	Supplemental			GPS Latitude/Longitude	
				Start	End
Item	2017 Storm Damage			38.241481 °	38.241439 °
				-121.544569 °	-121.544353 °
DWR ID	DWR_RD0003_02_f_2017_138				
Comment Code					
Inspector Comment					
Levee Evaluation Comments					
Description:District station 528+97 to 529+58, Sec. 33, T. 5 N. R. 4 E., M.D.M. Approximately 61 linear feet of erosion and sloughing exists along the water side slope of the Sacramento River (Unit 2). The erosion commences approximately 1/2 of the way down the slope from the crown and extends into the rip rap.					
Site ID No:280					
Site Designation:LMA-106					
Repair Type: Erosion					
Rating:Area of Concern					
Field Date:7/26/2017					
Notes:

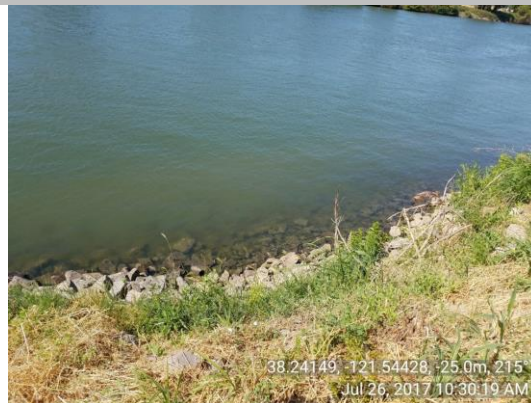
Photo 2 of 3 : SP\_2019\_RD0003\_25\_138\_20190311\_00105.jpg

LM Start	10.01	Rating **	A/W	Issue No.	138 (cont)	
LM End	10.03	Issue Type +	Ma	Location *		
Category	Supplemental			GPS Latitude/Longitude		
				Start	End	
Item	2017 Storm Damage			38.241481 °	38.241439 °	
				-121.544569 °	-121.544353 °	
DWR ID	DWR_RD0003_02_f_2017_138					
Comment Code						
Inspector Comment						
Levee Evaluation Comments						
Description:District station 528+97 to 529+58, Sec. 33, T. 5 N. R. 4 E., M.D.M. Approximately 61 linear feet of erosion and sloughing exists along the water side slope of the Sacramento River (Unit 2). The erosion commences approximately 1/2 of the way down the slope from the crown and extends into the rip rap.						
Site ID No:280						
Site Designation:LMA-106						
Repair Type: Erosion						
Rating:Area of Concern						
Field Date:7/26/2017						
Notes:

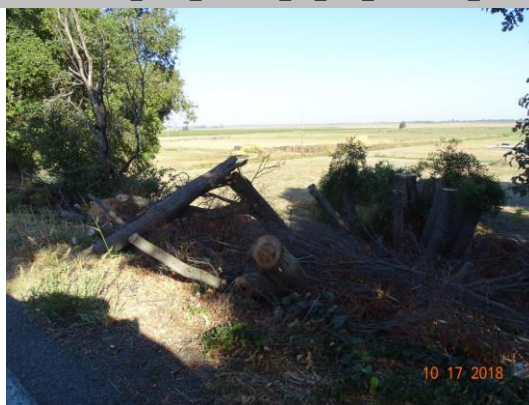
Photo 1 of 1 : SP\_2019\_RD0003\_25\_167\_20190311\_00143.jpg

LM Start	10.05	Rating **	U	Issue No.	167
LM End	10.05	Issue Type +	En	Location *	LS
Category	Earthen Levee			GPS Latitude/Longitude	
				Start	End
Item	Encroachments			38.241522 °	38.241522 °
				-121.543883 °	-121.543883 °
DWR ID	DWR_RD0003_02_f_2018_167				
Comment Code					
TR : Tree or limb					
Inspector Comment					
Remove tree debris from the landside slope.

View of partially removed tree on the landside slope (October 2018).

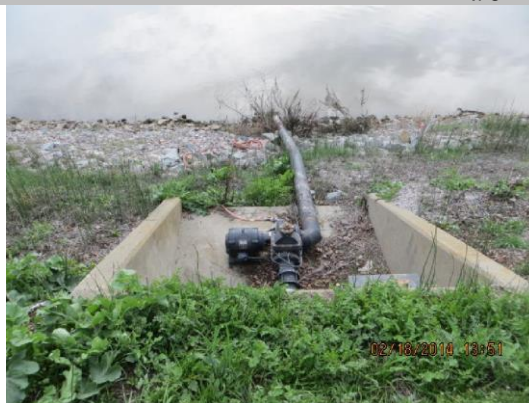
Photo 1 of 3 : UCIP\_SP\_2019\_30406\_55927.jpg

Comment Code					
Inspector Comment					
FS_ID:30406					
DS_ID:22281					
EP_NO: N/A					
Repair Type: Non-Urgent					
Crossing Status: Found					
UCIP Comments: Actuator for Gate valve is broken off.					
FIELD_STRUCT_DESC: 8-inch steel irrigation discharge pipe through the levee, invert elevation 6.5 feet below the crown. Pipe reduced to 6 inches on the slopes. Pump and gate valve on a concrete pad on the waterside (WS) slope. Siphon breaker on the landside (LS) slope. (DWR Bank Protection Project, Drawing No. 50-4-3741, Sheet 21 - Castanho). [Additional Reference(s): DWR Levee Log, 1993. USACE Sacramento O&M Manual 104, February 1960, (RM 25.09), 6-inch pipe referenced].					
FS Date: 2/18/2014

Pump, gate valve, and concrete pad on WS slope.

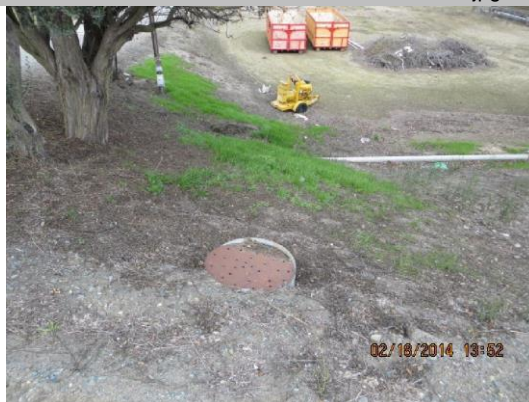
Photo 2 of 3 : UCIP\_SP\_2019\_30406\_55926.jpg

Siphon Breaker in CMP riser on LS shoulder.

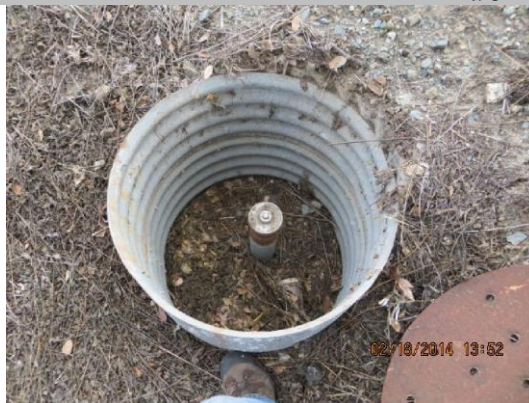
Photo 3 of 3 : UCIP\_SP\_2019\_30406\_55925.jpg

Item	DWR UCIP Field Study			38.241300 °		38.241300 °
				-121.542967 °		-121.542967 °
DWR ID	22281					
Comment Code						
Inspector Comment						
FS_ID:30406						
DS_ID:22281						
EP_NO: N/A						
Repair Type: Non-Urgent						
Crossing Status: Found						
UCIP Comments: Actuator for Gate valve is broken off.						
FIELD_STRUCT_DESC: 8-inch steel irrigation discharge pipe through the levee, invert elevation 6.5 feet below the crown. Pipe reduced to 6 inches on the slopes. Pump and gate valve on a concrete pad on the waterside (WS) slope. Siphon breaker on the landside (LS) slope. (DWR Bank Protection Project, Drawing No. 50-4-3741, Sheet 21 - Castanho). [Additional Reference(s): DWR Levee Log, 1993. USACE Sacramento O&M Manual 104, February 1960, (RM 25.09), 6-inch pipe referenced].						
FS Date: 2/18/2014

Siphon Breaker in CMP riser on LS shoulder.

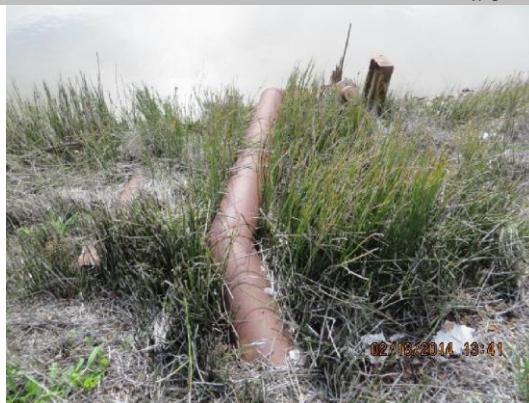
Photo 1 of 2 : UCIP\_SP\_2019\_30404\_55924.jpg

FS\_ID:30404  
DS\_ID:22282  
EP\_NO: 3670  
Repair Type: Non-Urgent  
Crossing Status: Found  
UCIP Comments: Appears abandoned as no pipe, siphon breaker, or standpipe visible on LS toe. If so, it should be abandoned properly.  
FIELD\_STRUCT\_DESC: 12-inch steel irrigation discharge pipe through the levee, 3.8 feet below the crown. Slant pump on the waterside (WS) slope. Siphon breaker on the landside (LS) shoulder. (Plans to remove an old centrifugal pump and suction pipe, to install a new propeller pump 40 feet in length along the slope of the levee, to install necessary foundation piling to support the pump, and to connect to present pipe through the levee authorized under Permit No. 3670, 1961 - Russell G. Graham. Plans to replace a section of an existing irrigation pipe with a 12-inch steel pipe through the crown of the levee authorized under Permit No. 17837, 2004 - Ron Galindo). [Additional Reference(s): DWR Levee Log, 1993].

Pipe and slant pump visible on WS slope.
